COUNTRY	Poland	REPORT
SUBJECT	1. Harbor Installations in Wladyslawowo 2. Harbor Installations at Gornoslaski Quay in Szczecin	DATE DISTR.
DATE OF INFO.		17 October 1955
PLACE ACQUIRED		NO. OF PAGES
DATE ACQUIRED		REQUIREMENT NO.
		REFERENCES

[redacted] report, with an attached
sketch, of installations in the harbor of Wladyslawowo (N 54-48, E 18-25),
and a report concerning ship sightings in Swinoujscie (Swinemuende)

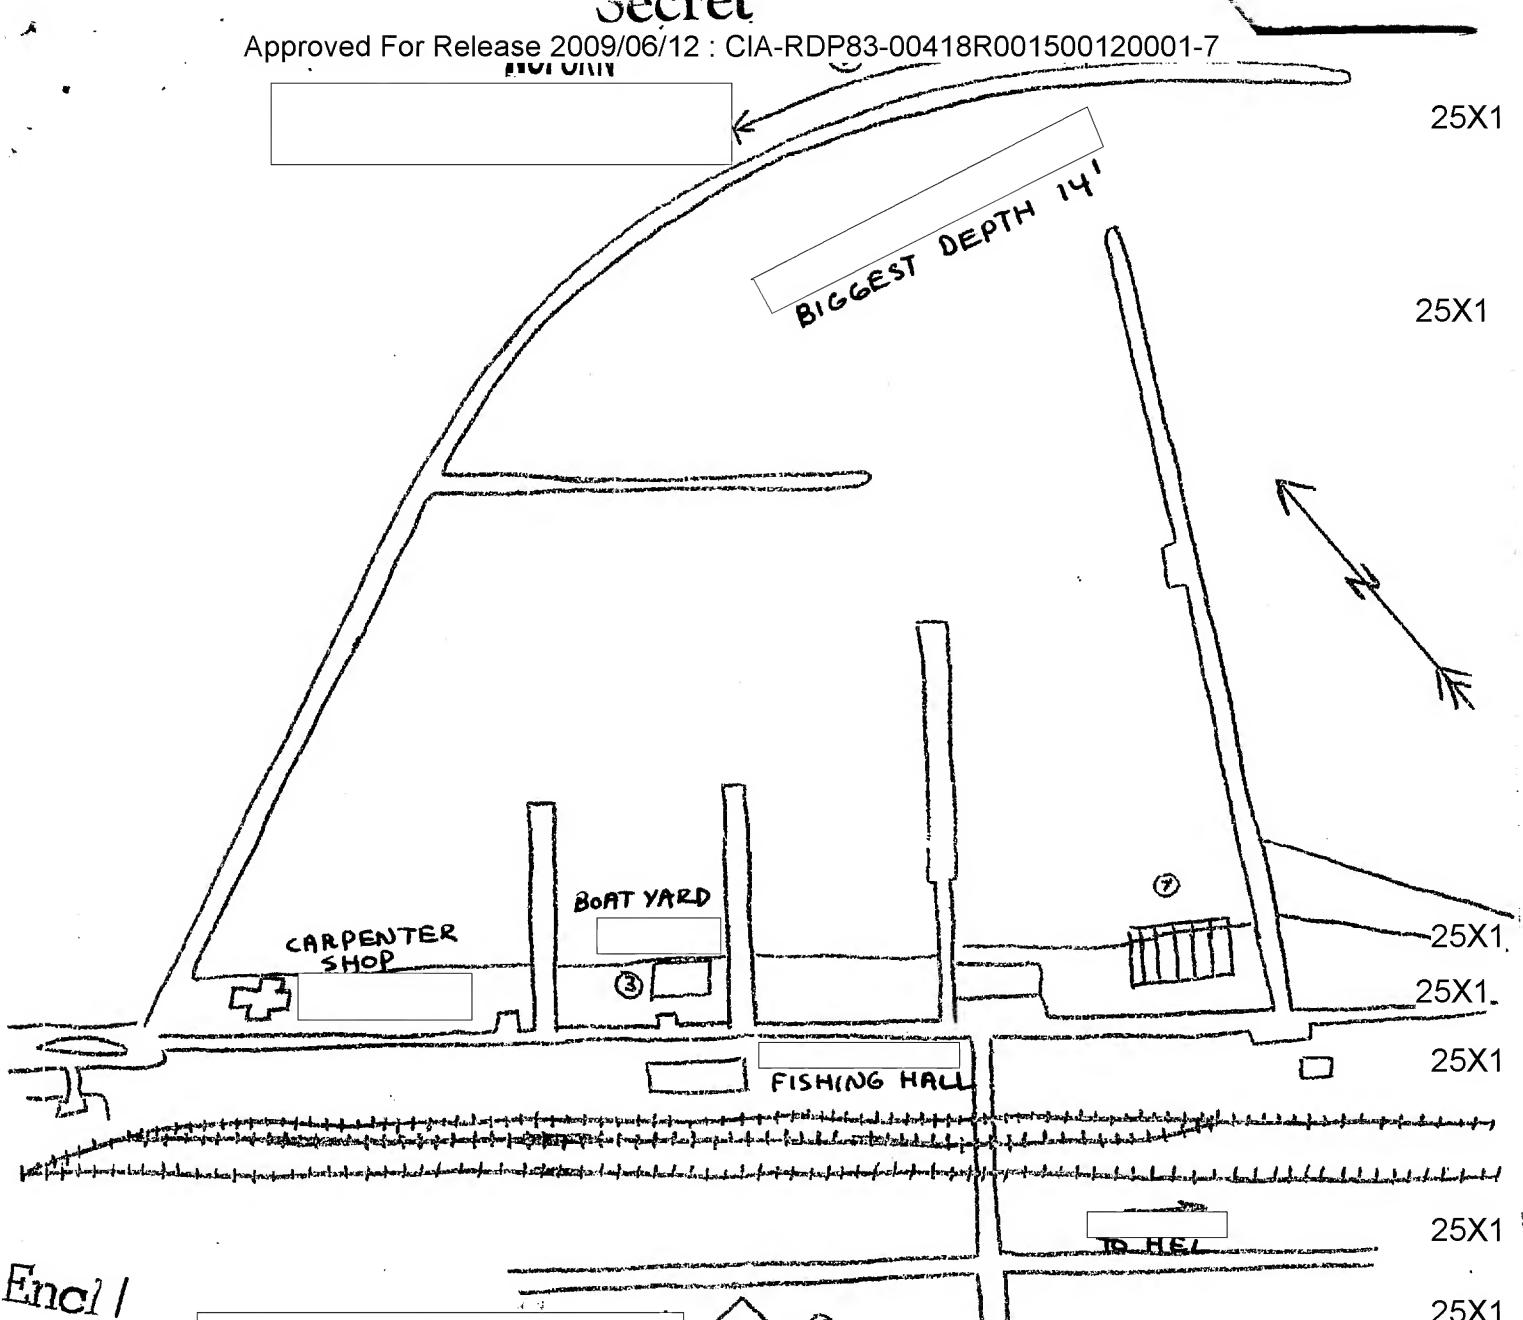
2. Explanation of the Drawing

transverse slip for vessels of an estimated 500 tons has been built. The fish industry facilities have grown and improved. Otherwise the harbor has not changed much; there are no special new buildings. The war damages have been repaired. There were more than one hundred fishing vessels in the harbor. No naval vessels.

1. New transverse slip for repairs of fishing vessels.
2. New fishing industry building in two floors. On the top floor there is housing for the factory workers. The building is not completely finished.
3. Small boat yard. Only the smallest fishing boats can be built here.
4. The mole repaired on this piece.
